ARMOR SUCCESS STORY

Customer: Ford Motor Company

Type of industry: Transmission and Transmission Components

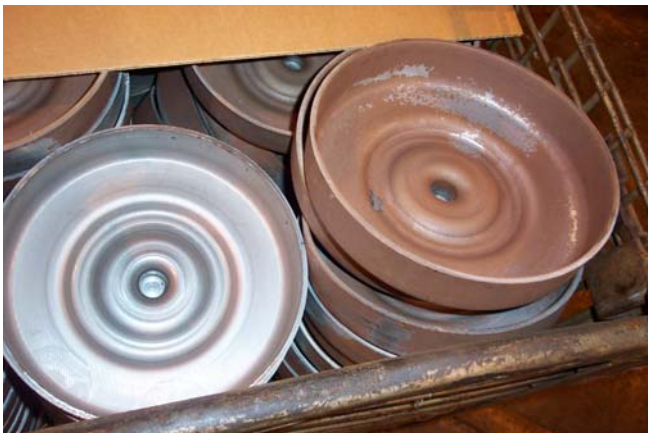
Problem: Conducted testing to isolate variables and found that the warm parts placed inside the container and competitive VCI bag created a "greenhouse effect" which resulted in moisture in the container and eventually rust on the hubs. The "cost" of these complaints and the de-rusting efforts to resolve them exceeded, on average, \$125,000 per year, not including transportation, re-work, administrative costs or cost incurred by their customers in handling and managing returns. Obviously, this method was not working.

Rust Prior to ARMOR's Solution

Solution: ARMOR recommended several process changes in the plant including a brief cool down time before closing the bags. In addition, Ford placed large sheets of ARMOR WRAP® 30R Paper as interleaving between several layers of hubs. An ARMOR POLY® VCI Bag was used to line the cages and this combination proved successful in eliminating the rust.

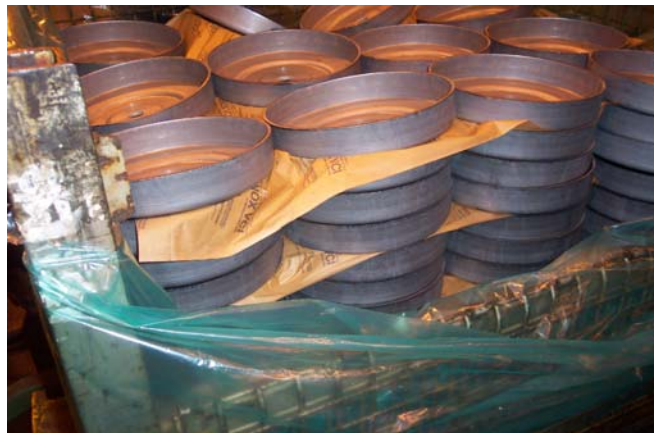
ARMOR WRAP® 30R and ARMOR POLY® Bag
